4. TITLE (and Subtitle) Phase I Inspection Report National Dam Safety Program Aviation. Golf and Farm Club Dam Bath County, Virginia		5. TYPE OF REPORT & PERIOD COVERED Final

NAME OF DAM: AVIATION, GOLF AND FARM CLUB DAM
 LOCATION: BATH COUNTY, VIRGINIA
 INVENTORY NUMBER: VA. NO. 01703

PHASE I INSPECTION REPORT NATIONAL DAM SAFETY PROGRAM

Name of Dam: Aviation, Golf and Farm Club Dam
State: Virginia
County: Bath
USGS Quad Sheet: Bath Alum
Coordinates: Lat 38° 03.2' Long 79° 43.2'
Stream: Branch of Jordan Run
Date of Inspection: April 16, 1980

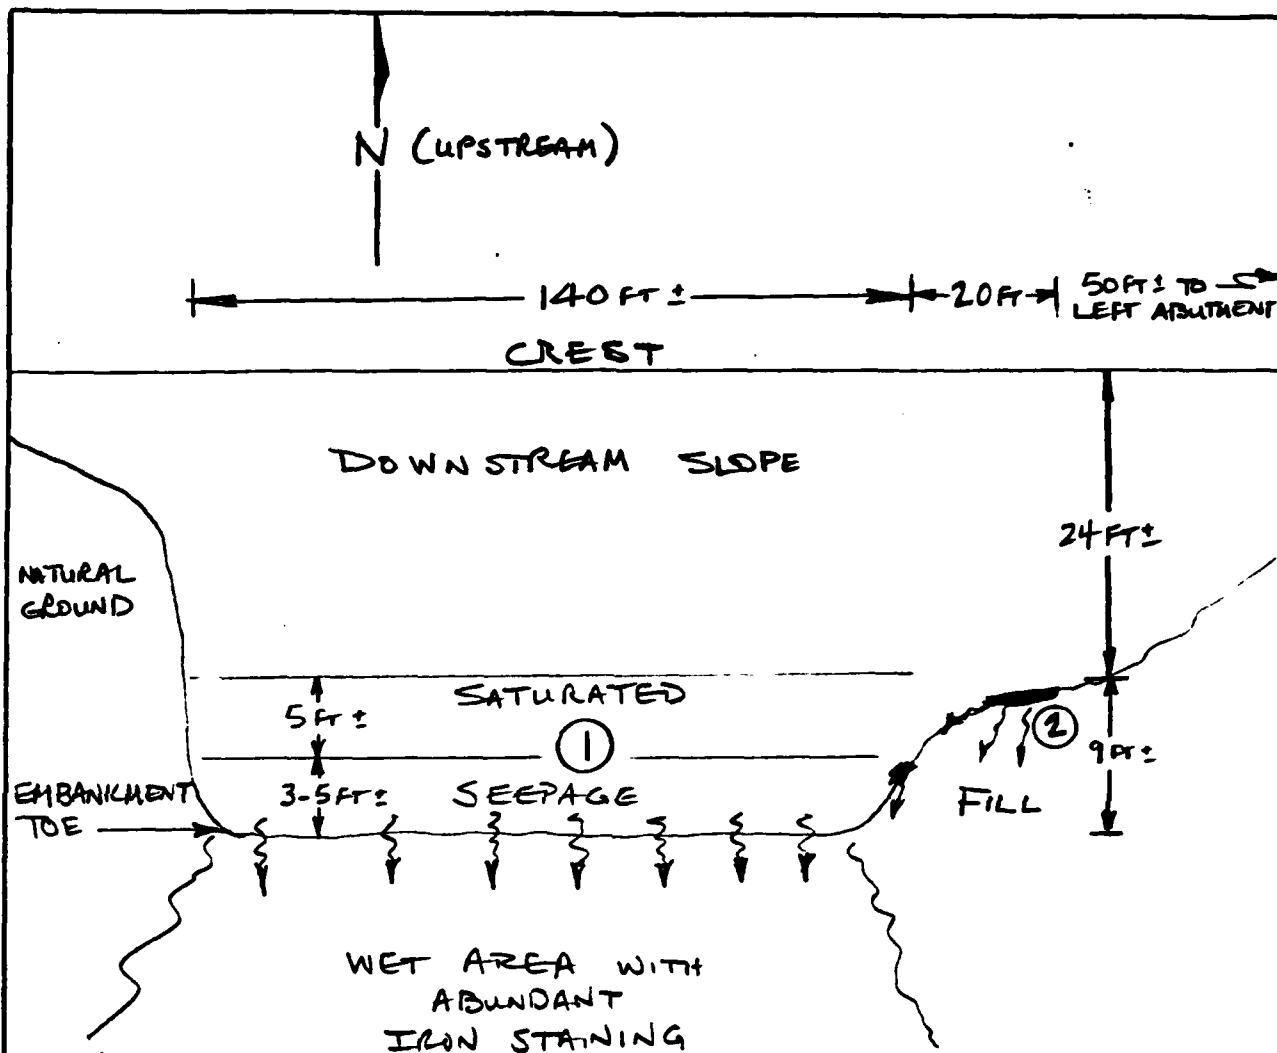
SHEET NO. 1 OF 2
 JOB NO. V80102

3.1.2 Dam and Spillway: Both the upstream slope and the downstream slope were covered with brush, briars, and a number of trees up to 12 inches in diameter. Rutting was observed along the crest roadway and severe erosion existed in the roadway in conjunction with the 15" CMP which is one of the principal spillways. Numerous undulations and some scattered surface washes were noted on the downstream slope. The upstream slope included riprap, which appeared to be functioning as planned. Field measurements indicate slopes are 2H:1V on the upstream face and 1.6H:1V on the downstream face. The dam appears to be constructed with assorted combinations of sand, silt, clay, gravel, and boulders. Considerable seepage was observed along the basal 3 to 5 ft of the downstream toe while saturated conditions existed 5 to 10 ft above the lowest point on the downstream slope. Additional seepage was encountered along the left embankment abutment. Contact seepage areas are illustrated on field sketch, Sheet 1 of Appendix III.

Considerable seepage with accompanying iron staining was observed along the toe of downstream slope. Seepage was present along the basal 3 to 5 ft while saturated conditions existed 5 to 10 ft above the lowest point of the downstream slope. Additional seepage was located along the edge of the left abutment. See the accompanying field sketch, Sheet 1.

- ① SEEPAGE CONCENTRATED IN BASAL 3-5 FT ± WITH SCATTERED FLOW AT LESS THAN 1 GPM. SATURATED SLOPE APPROXIMATELY 5 FT WIDE EXISTS ABOVE THE BASAL AREA.
- ② AREA OF LOCALIZED SEEPAGE ; 20 FT ± LONG AND 5 FT ± WIDE WITH ABUNDANT IRON STAIN. OBSERVED FLOW LESS THAN 1 GPM.

7.3.1 Widespread seepage present along the downstream slope should be monitored quarterly and after periods of high pool levels in the reservoir to detect any increases in flow rates which may cause piping within the embankment.

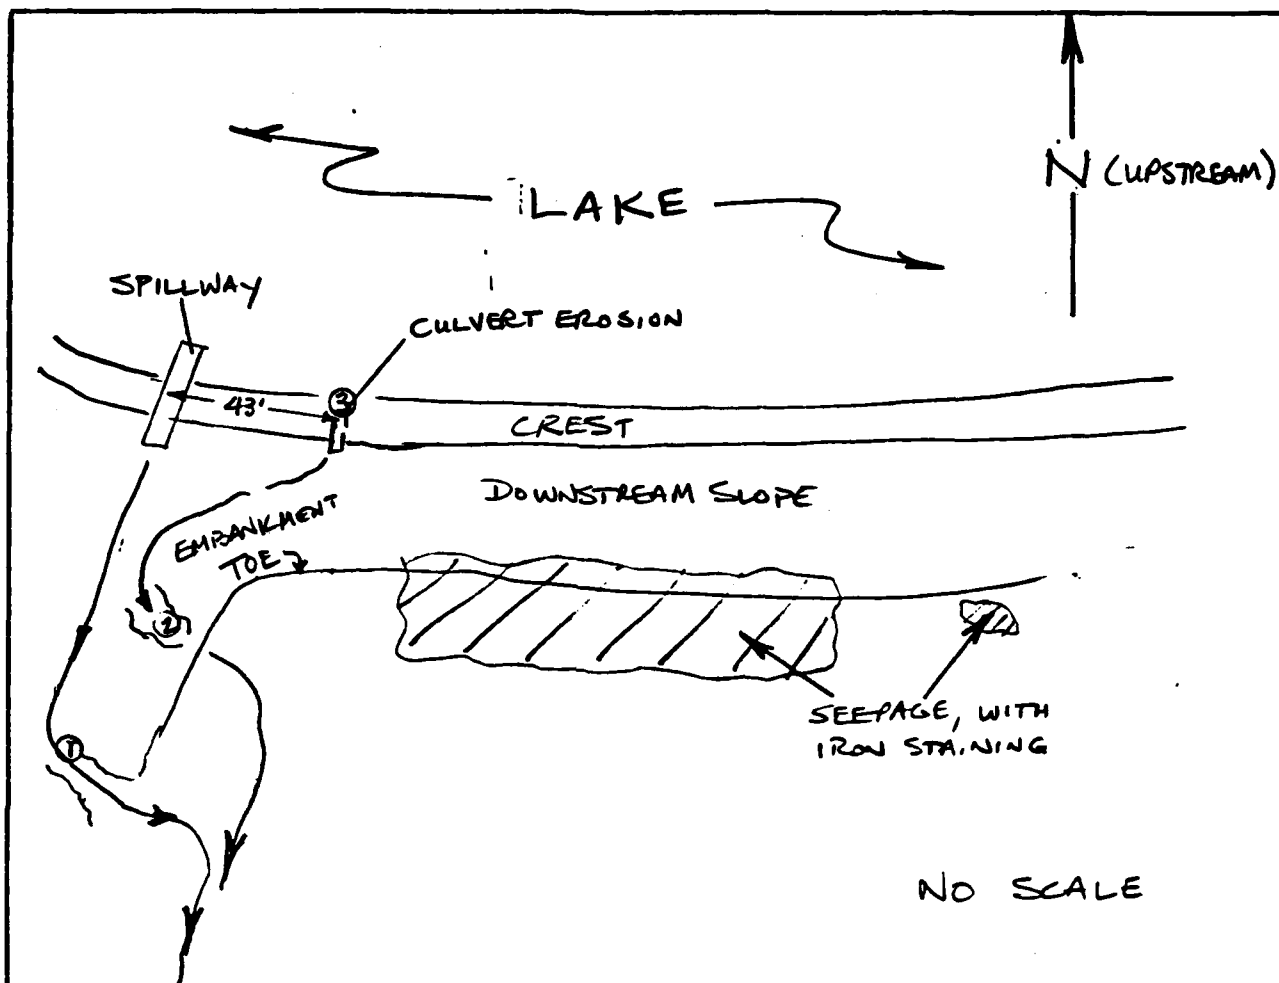
SHEET NO. 2 OF 2
JOB NO. V80102

The spillway outlet pipes of the principal spillway showed no signs of deterioration, however, the outlet channels for these pipes were eroded at the plunge pool area due to a lack of riprap. The lower end of the outlet channels were badly eroded and include approximately 20 ft vertical drops in their channels in approximately a 5 ft horizontal distance. See the field sketch, Sheet 2, Appendix III.

- ① ERODED AREA IN MAIN SPILLWAY CHANNEL; 20-25 ft ± WIDE, 15 ft ± DEEP. PRESENTLY UNDERMINING A LARGE TREE BOUNDING THE NORTH SIDE OF CHANNEL.
- ② ERODED AREA OFF MAIN CHANNEL; 10-20 ft ± WIDE AND 15 ft ± DEEP. FILLED IN PART WITH LARGE BLOCKS OF ROCK
- ③ EROSION FROM EDGE OF POOL TO POINT 7 ft ± INWARD. ERODED AREA IS 7 ft ± LONG, 3 ft ± WIDE AND 4 ft ± DEEP. EROSION IS AROUND 16" ± CMP

Repairs needed where outlet channels are eroded.
